Record of Survey for;	SHT
CITY OF BREMERTON	1
Situate in the,	OF
Govt. Lot 3	2
(NE.1/4 NE.1/4)	
SEC. 14, TWP. 24N.,	
RG. 1E., W.M.

LEGAL DESCRIPTION

Record of Survey for;
CITY OF BREMERTON
Situate in the,
Govt. Lot 3 (NE. 1/4 NE. 1/4) SEC. 14, TWP. 24N., RG. 1E., W.M.

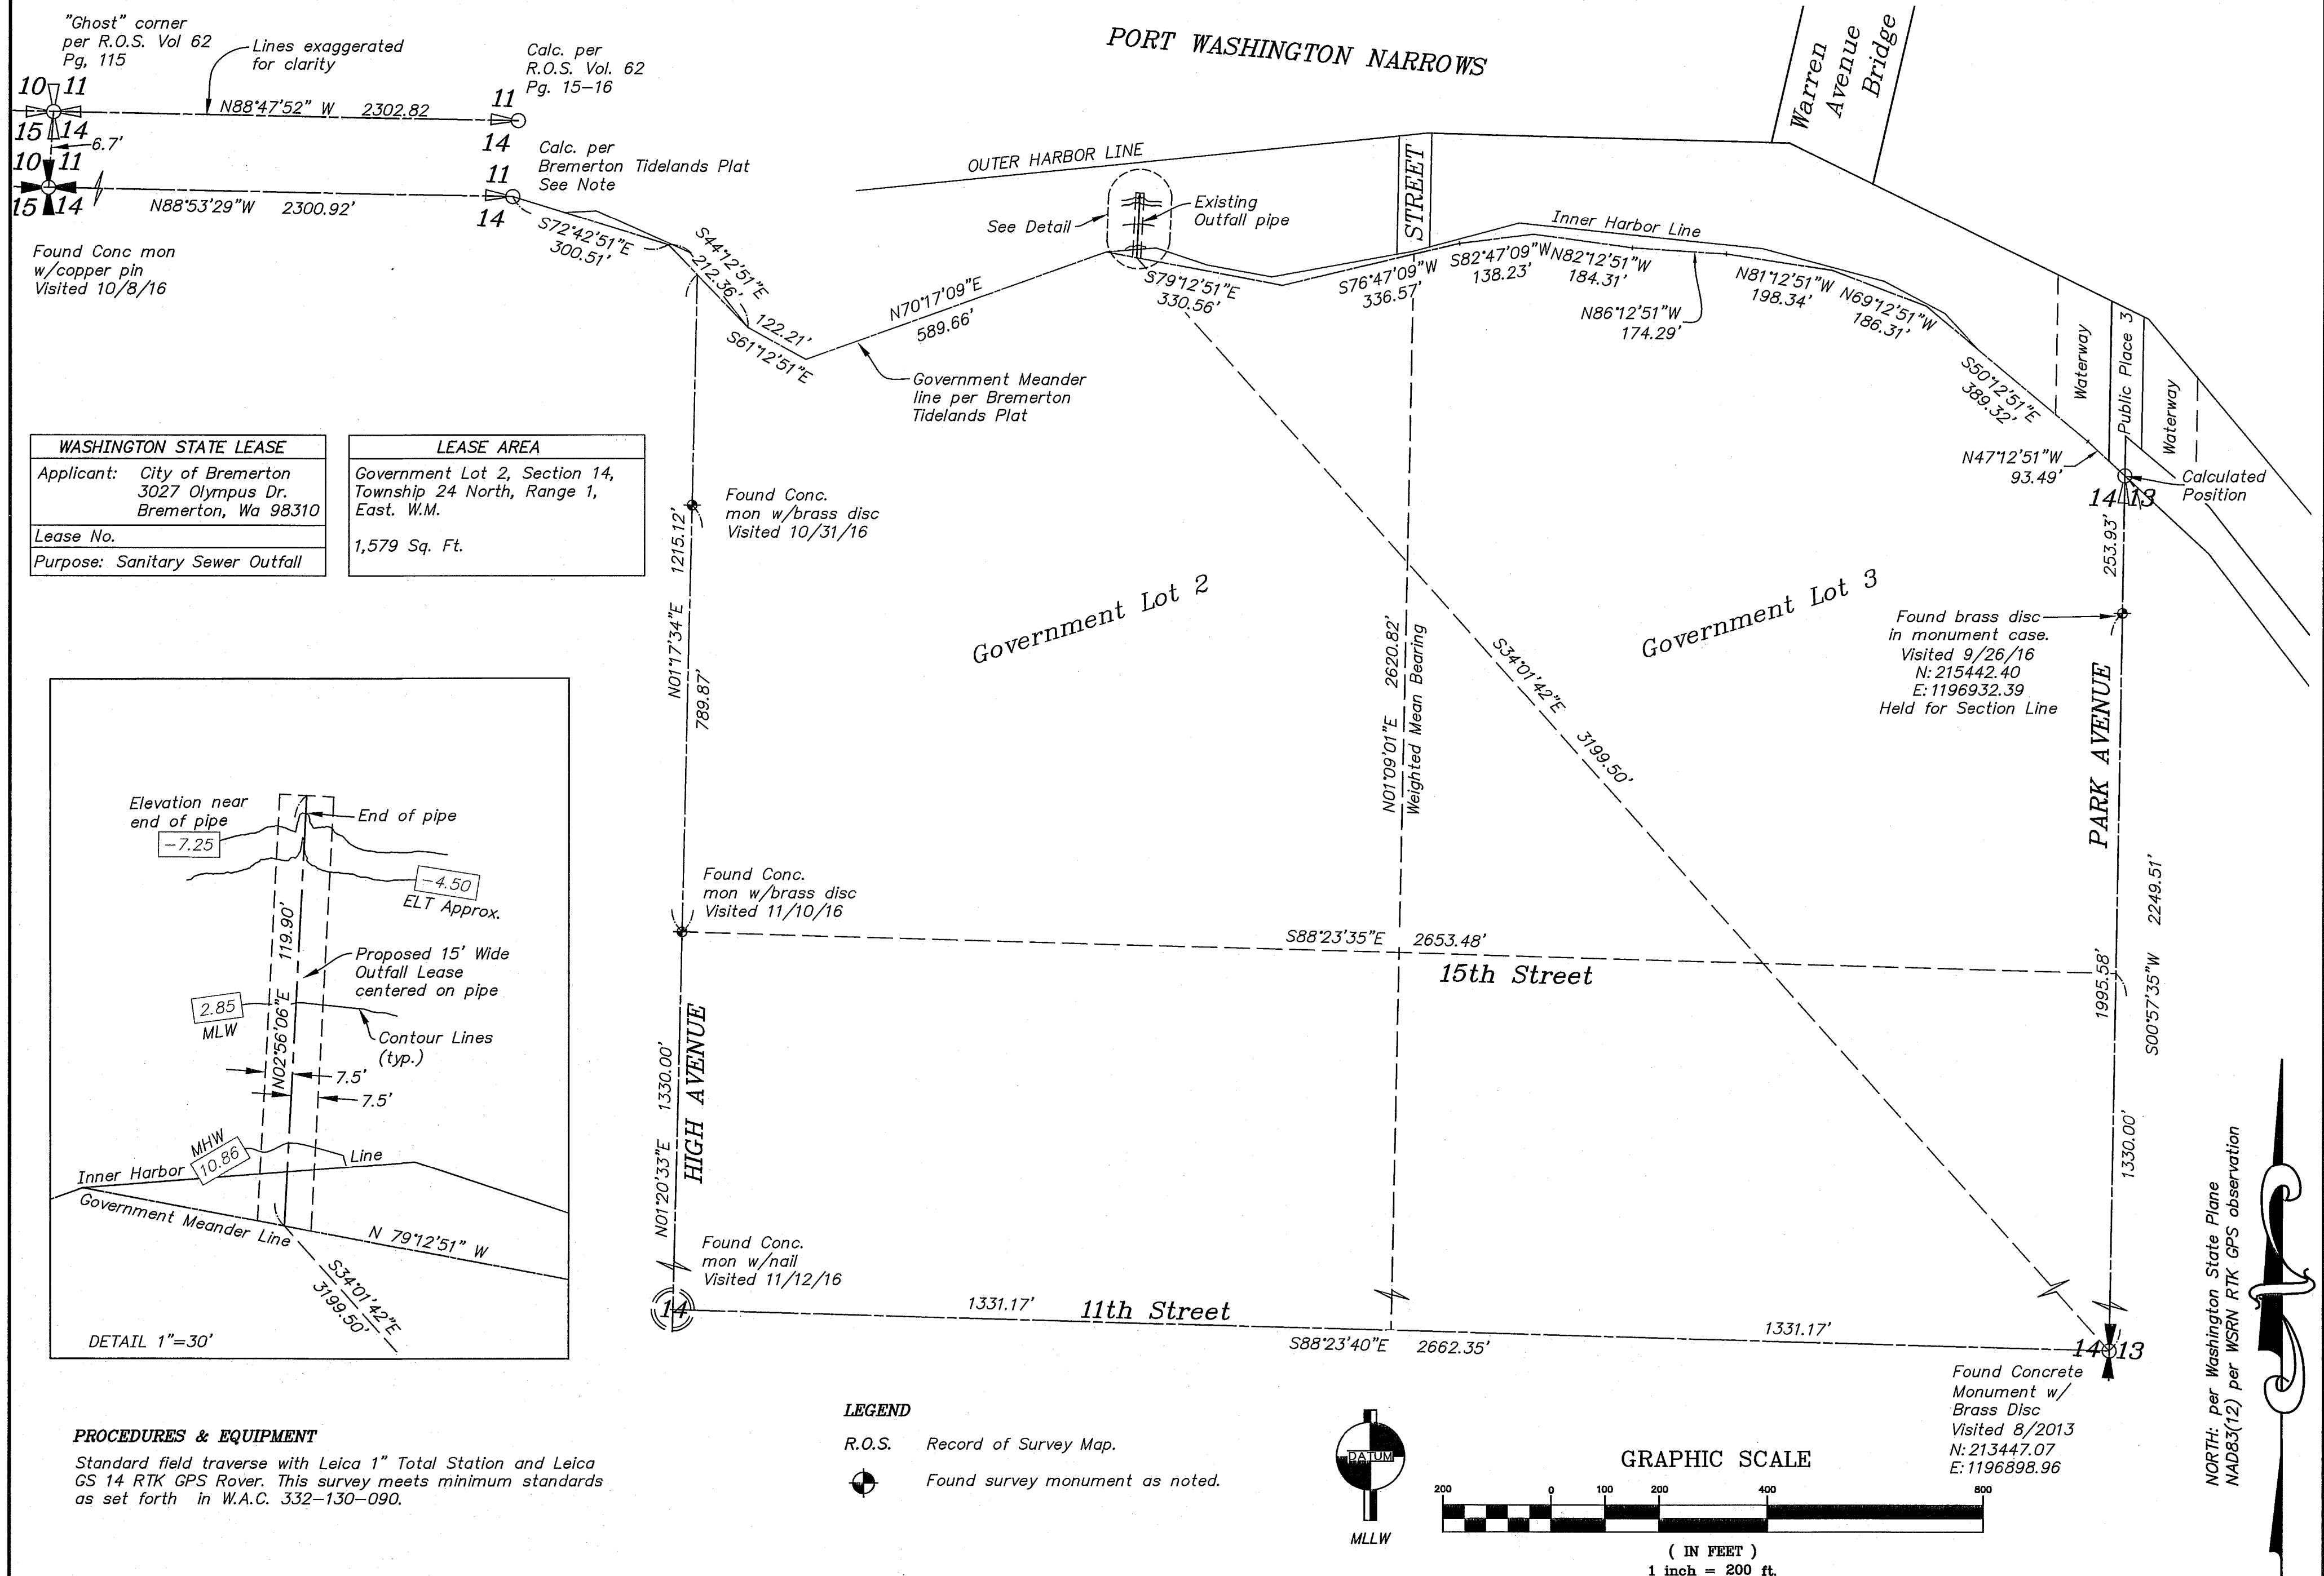
Horizontal datum is Washington State Plane Coordinate System NAD83(12), North Zone, as derived from GPS observation from ties to the Washington State Reference Network, WSRN, on the monuments shown on this survey.

Vertical Datum is MLLW determined by GPS observations in NAVD88 and converting to MLLW based upon NOAA conversion for Bremerton, WA station No.9445958.

The location of the outfall and pipe alignment is from eTrac Engineering bathymetric survey, September 2016. AES Consultants confirmed the pipe alignment by measuring the location of the connecting sewer manhole. The easement alignment is centered on the pipe, which is not shown for clarity. Records show the pipe is 24" CI pipe.
